# High-speed rail inspection by non-contact sensing and advanced processing

A.Z. Hosseinzadeh, I. Batista, C. Huang, & F. Lanza di Scalea,  
Experimental Mechanics, NDE and SHM Laboratory, UCSD, San Diego, USA

IHHA 2025

13TH INTERNATIONAL HEAVY HAUL  
ASSOCIATION CONFERENCE 2025

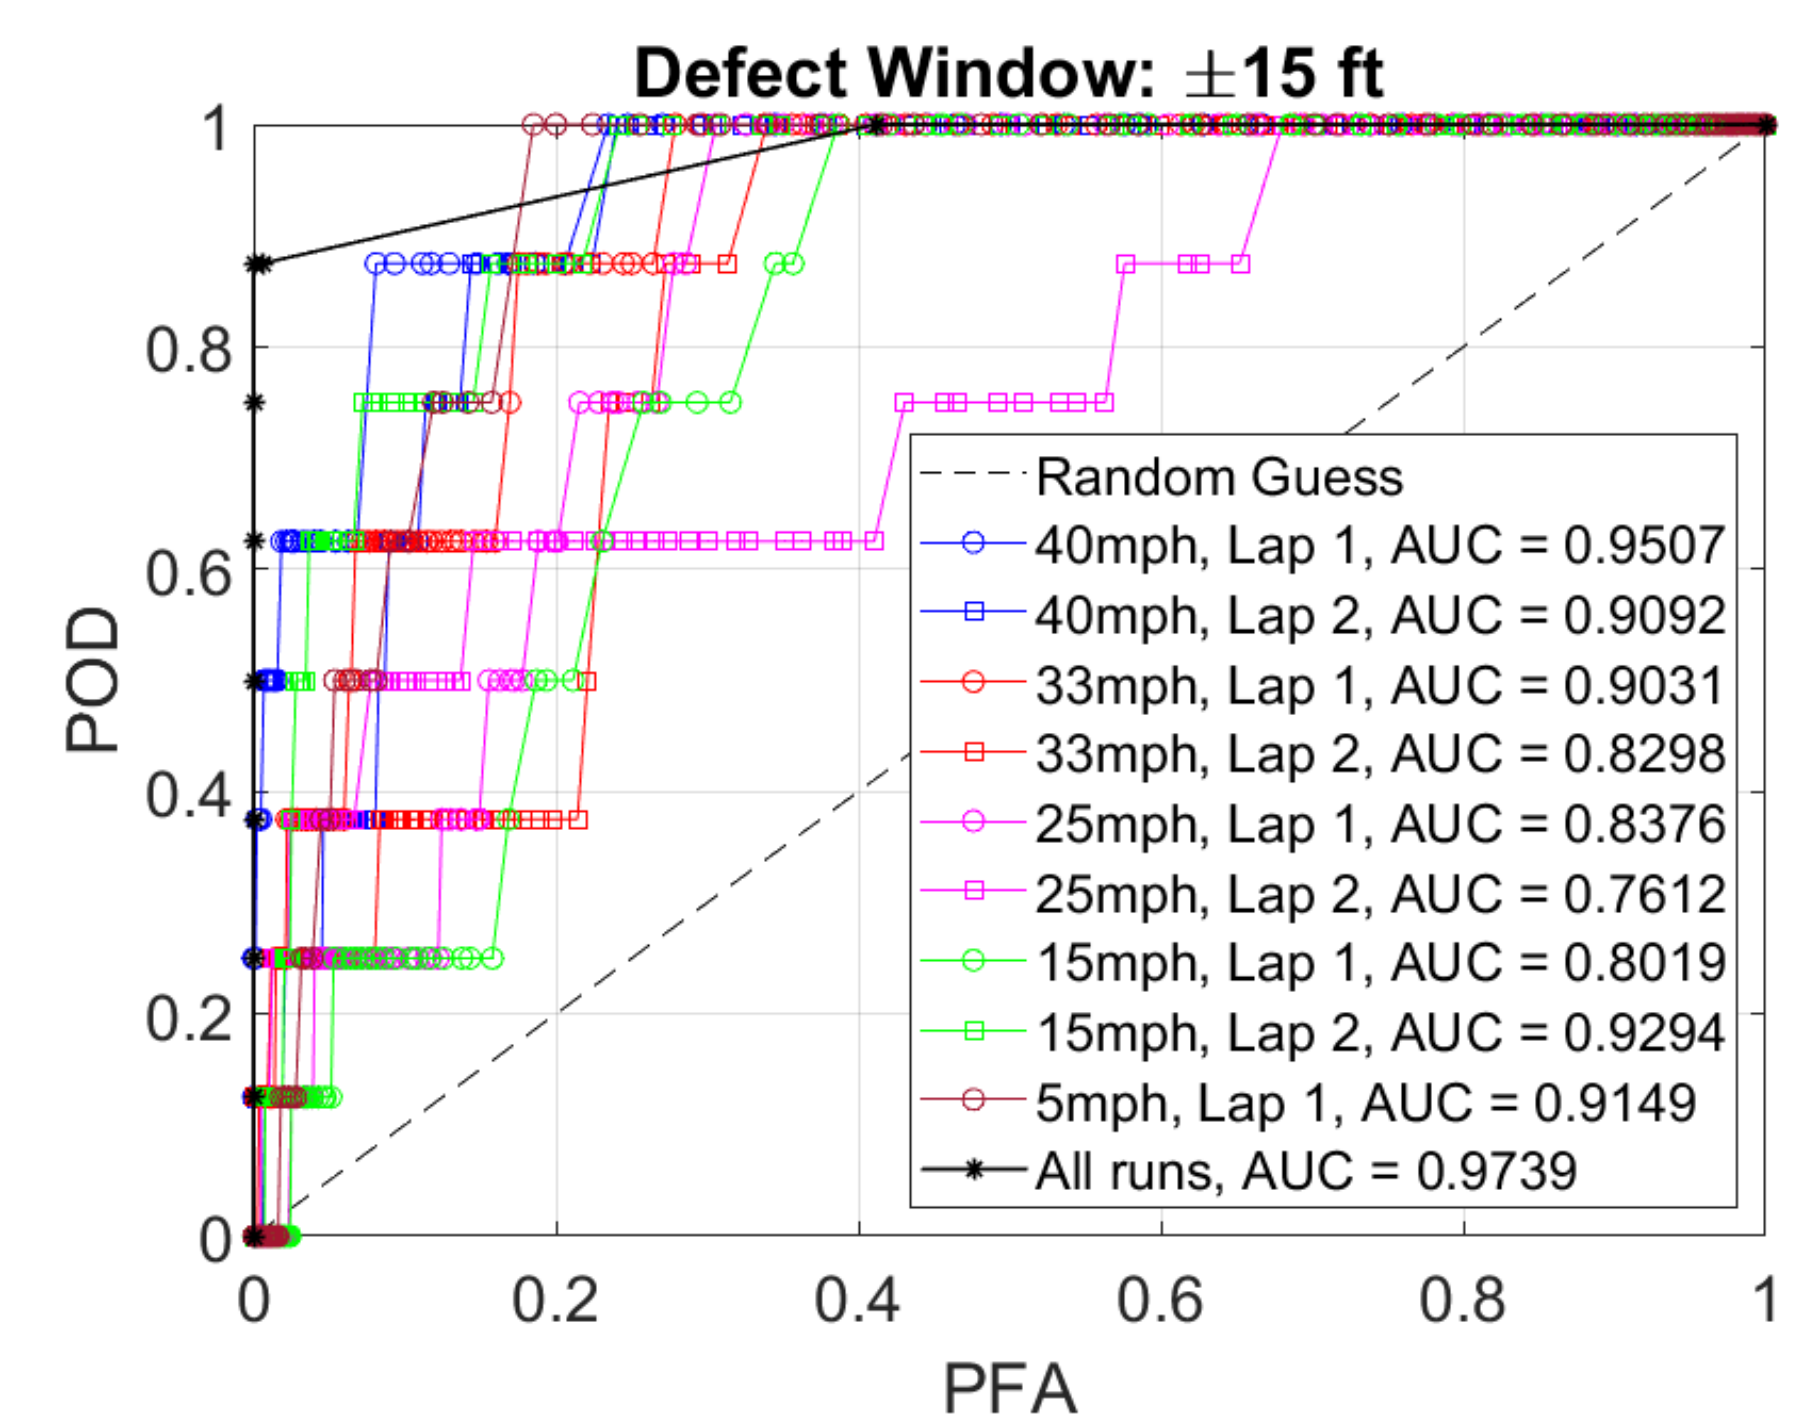
Figure 3: ROC curves for TDs using feature  $F_1$ . AUC: Area under curve.

Results are shown from tests conducted at TTC (Pueblo, CO) with an FRA research car at different speeds. Two features are used to extract the damage index: inverse of variance (feature  $F_1$ ) and variance ratio (feature  $F_2$ ). Figure 2 shows DI for a sample test run at 40 mph using  $F_1$ . Test redundancy (repeated passes over the same test track) is also leveraged. The performance of the system is assessed by computing Receiver Operating Characteristic (ROC) curves that best determine the achievable tradeoff between the Probability of Detection (POD) and the Probability of False Alarms (PFAs). Results shown in Figures 3 and 4 reveals the constructive effects of redundancy concept in obtaining perfect detection rate. Also, the positive effect of using feature  $F_2$  (as a more localized feature) in improving the performance of the method is emphasized.

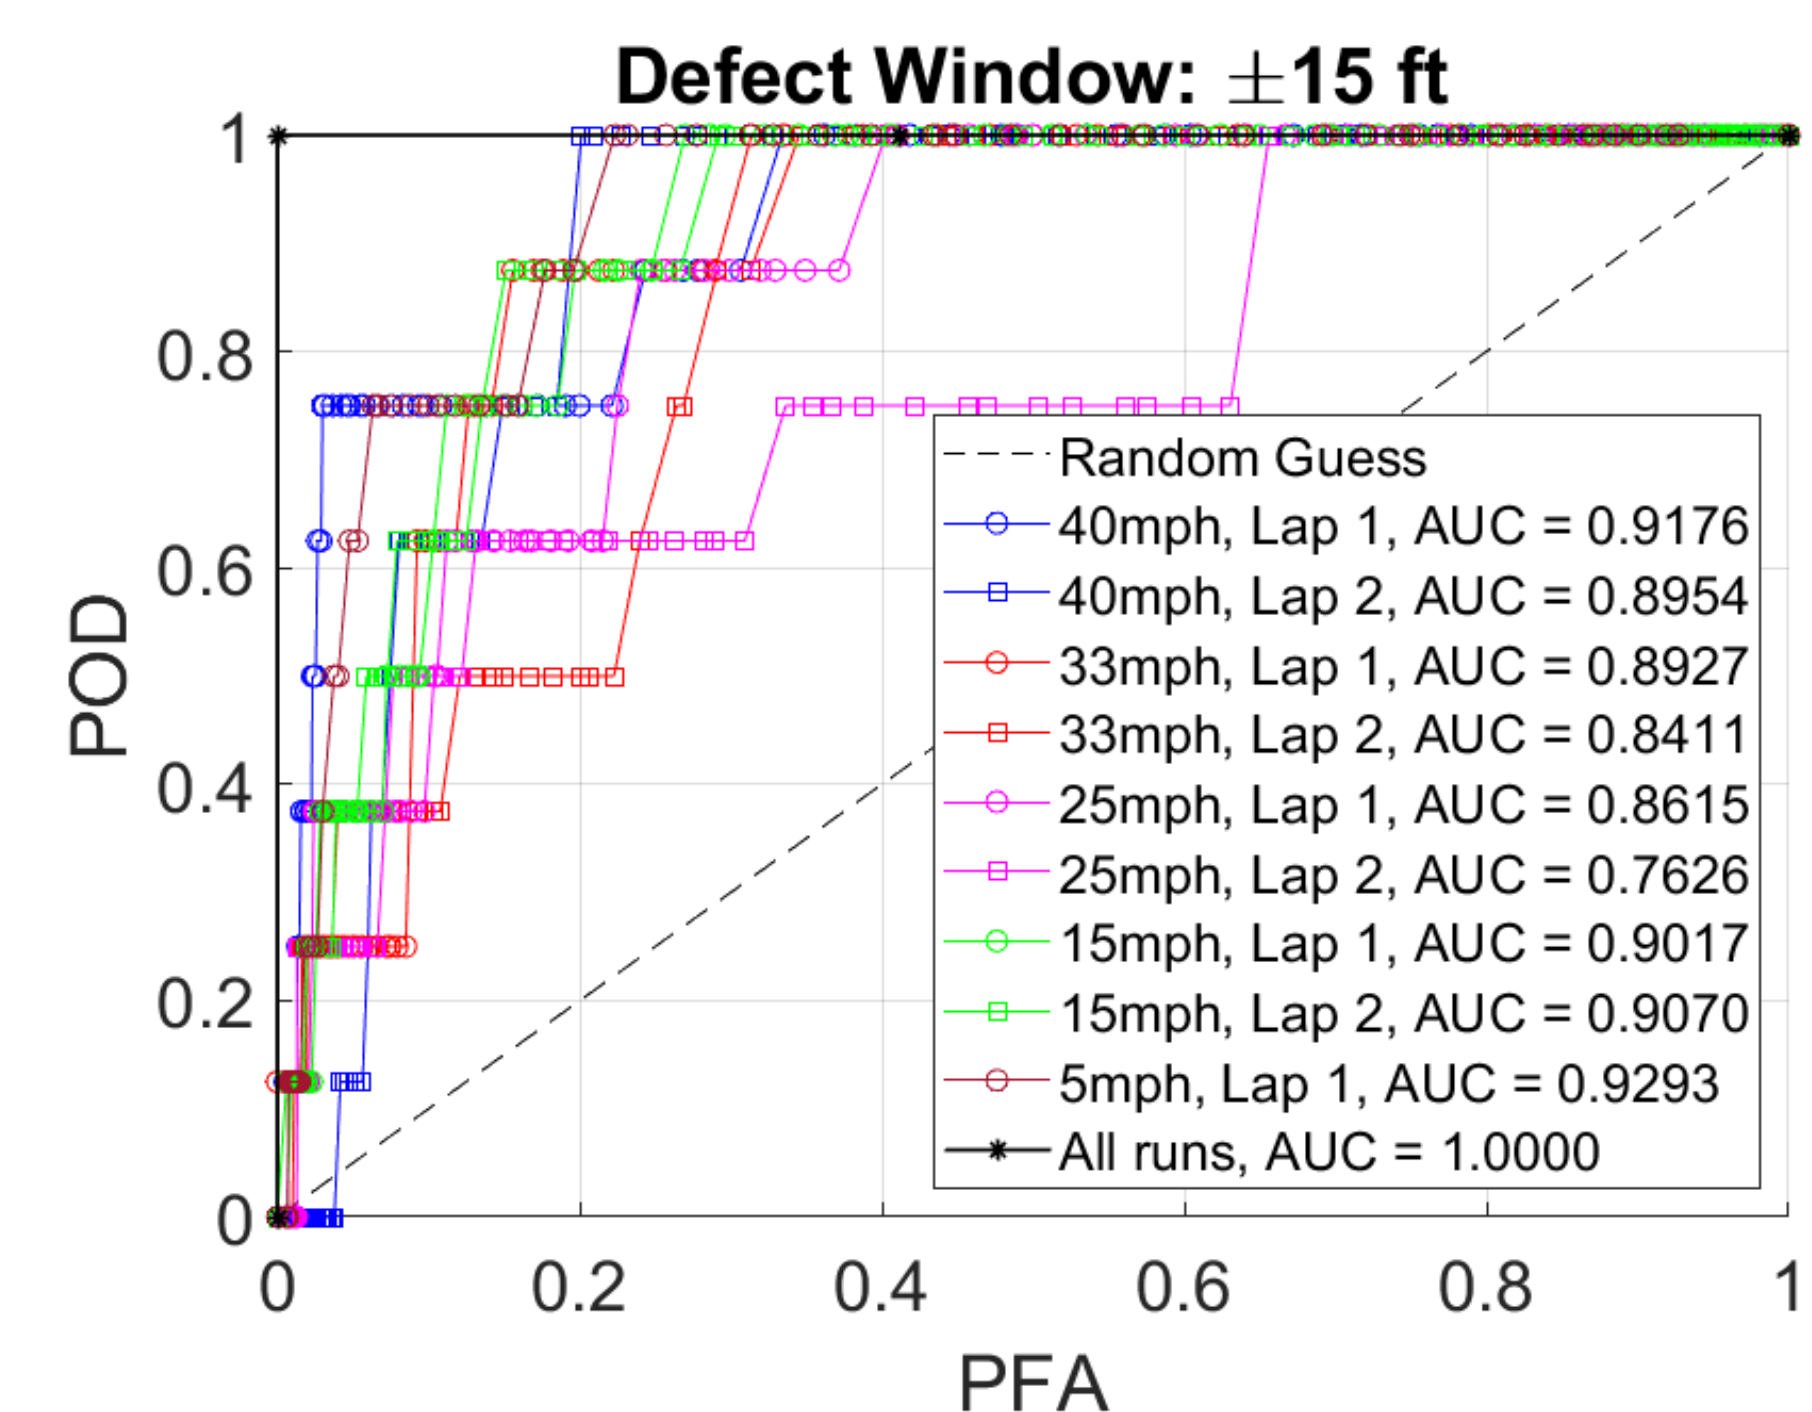
Figure 4: ROC curves for TDs using feature  $F_2$ . AUC: Area under curve. “Defect Window” is the spatial size of detection window flagging as true.
